Property Inspection Report

Demo Report - 10013 River Drive Las Vegas, NV 89119

Date of Inspection
December 10th, 2020
11:30 AM

Inspected By
John Smith
InterNACHI #123456

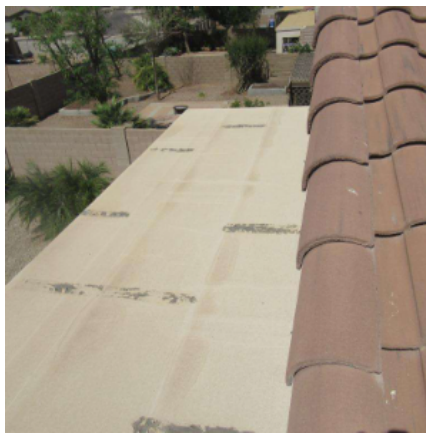
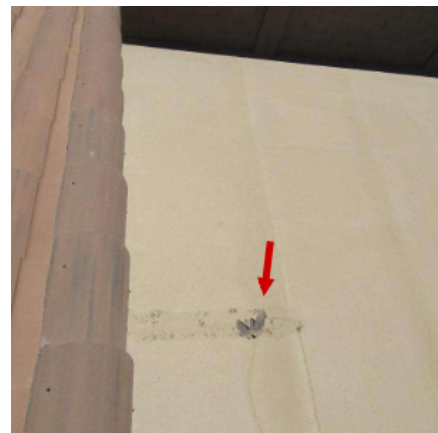
Roof Coverings / Materials
Section 2.2
Page 10

- Description**
- Concrete Tile
 - Rolled Composite
- Condition**
- Slipped
 - Peeling
- Location**
- Front of Home
 - Patio

Tile slipped from original position at north center gable above garage. Repairs may be made by the homeowner or a handyman.

Peeling coating from roofing joints on the south patio roof.

Repair or Replace

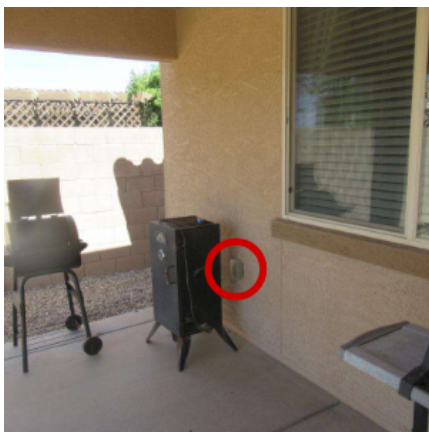
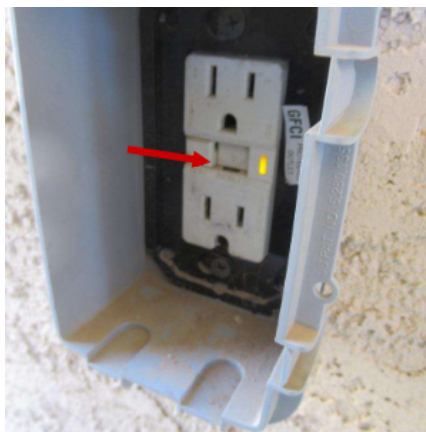
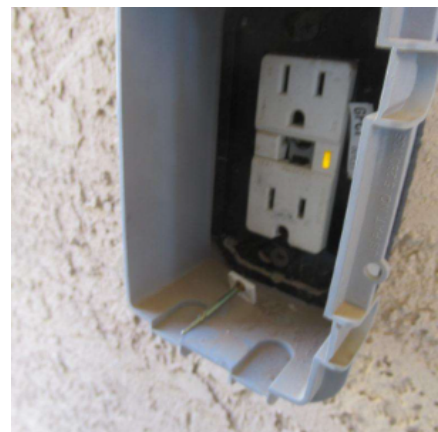
GFCI
Section 3.3
Page 13

- Description**
- Present
- Condition**
- GFCI Inoperable
- Location**
- Exterior
 - South-West Corner

The test button on the GFCI is broken and should be repaired or replaced immediately.

Repair or Replace

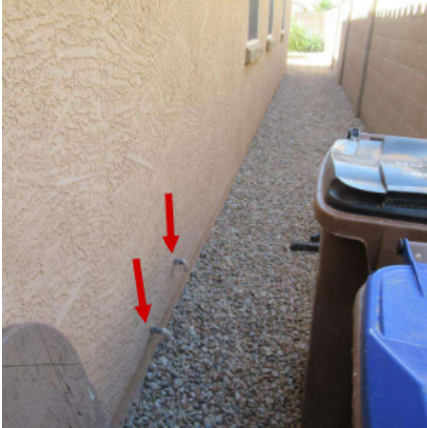
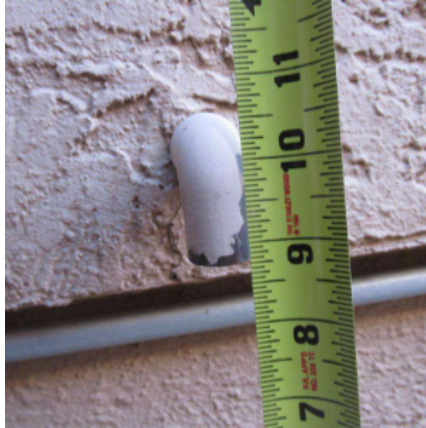
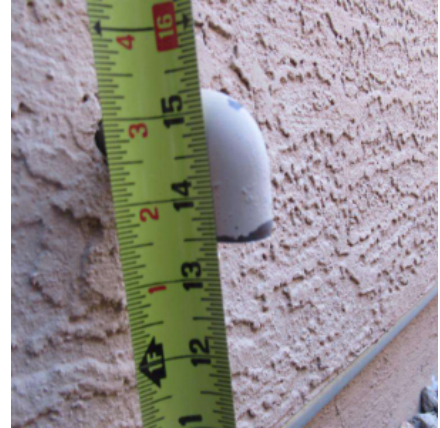
Drain, Waste, Vent Piping

- Description**
- ABS Plastic
 - PVC
- Condition**
- Improper Length
- Location**
- Exterior
 - West Wall

Water heater discharge pipe is too short/far from ground. Steam dissipation can cause scalding to those standing nearby. Typically this should terminate 6 inches from the ground, but may vary by jurisdiction.

Repair or Replace

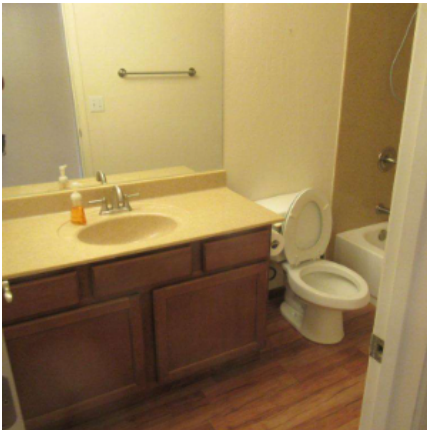
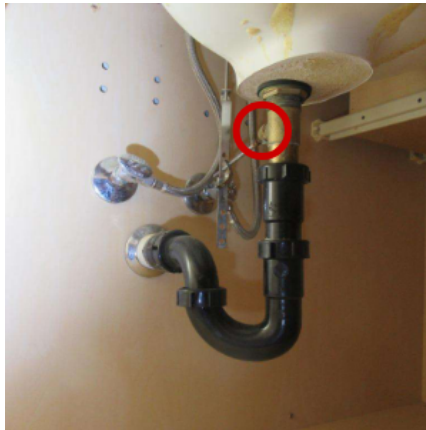
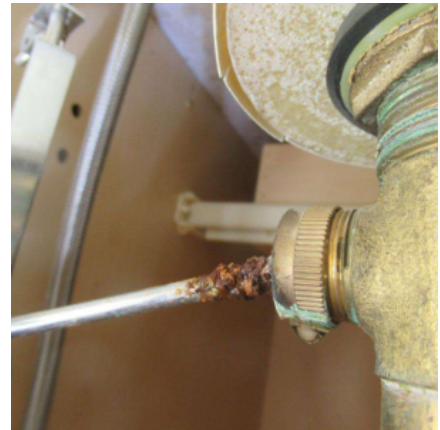
Bathroom Sinks

- Description**
- Single Vanity
- Condition**
- Leaking
- Location**
- Master Bathroom

A leak is present at the stopper rod/drain connection. The mechanism can be dismantled to check seals for wear or cracks.

Repair or Replace

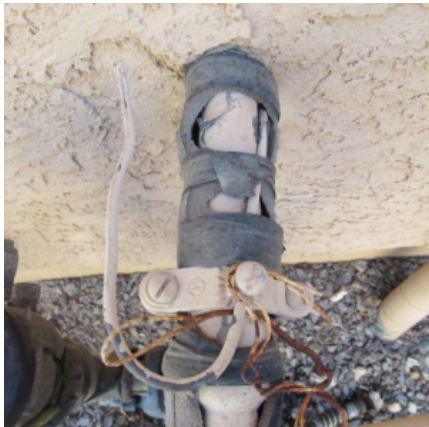
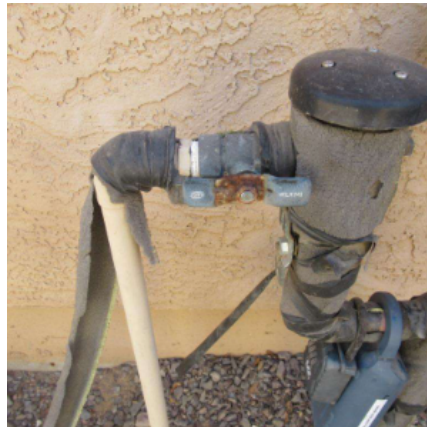
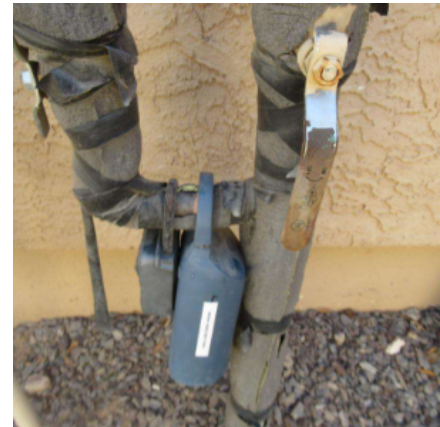
1.1 Hose Bibbs / Outdoor Faucets

- Deteriorated Insulation

- Freezing during extreme weather in winter

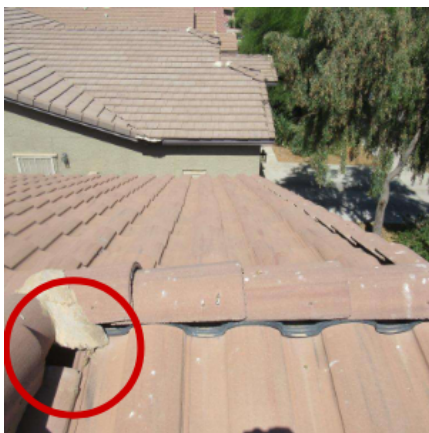
Repair or Replace - Immediately: Tile slipped from original position at north center gable above garage. Repairs may be made by the homeowner or a handyman.

Image 2.2.1 Roof tile has slid out of place - NE Corner of Home

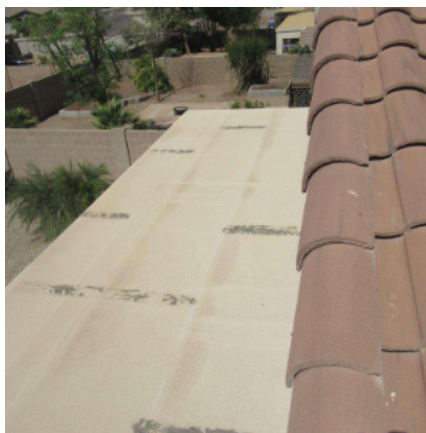
Peeling coating from roofing joints on the south patio roof.

Image 2.2.2 Peeling coating from joints on patio roof

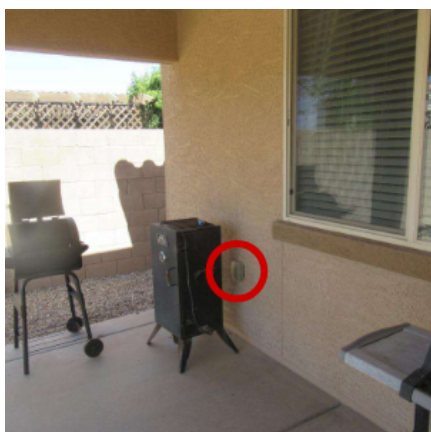
| Condition | • GFCI Inoperable | Risk | • Electrocutation Hazard |

Image 3.3.1 Broken GFCI Location

Repair or Replace - Immediately: The test button on the GFCI is broken and should be repaired or replaced immediately.

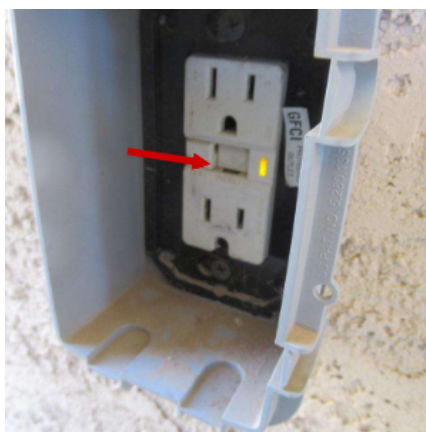
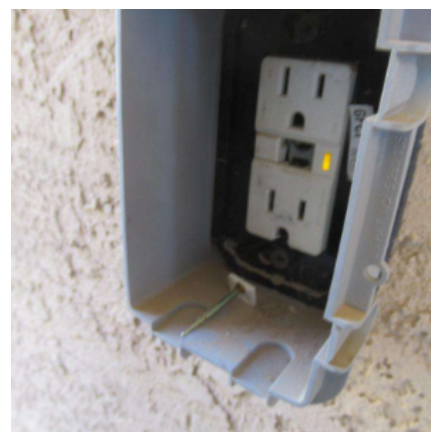
Image 3.3.2 Broken GFCI Test Button

Image 3.3.3 Broken GFCI Test Button

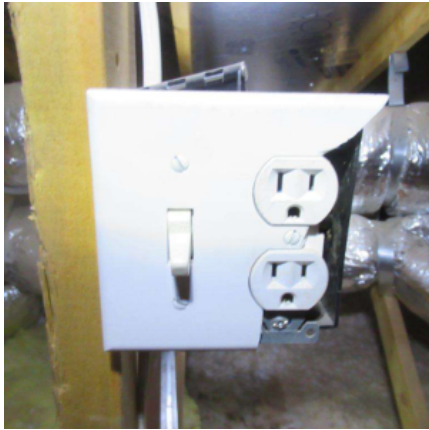
| Condition | • Damaged | Risk | • Electrocutation Hazard |

Image 3.4.1 Broken Outlet Cover

Repair or Replace

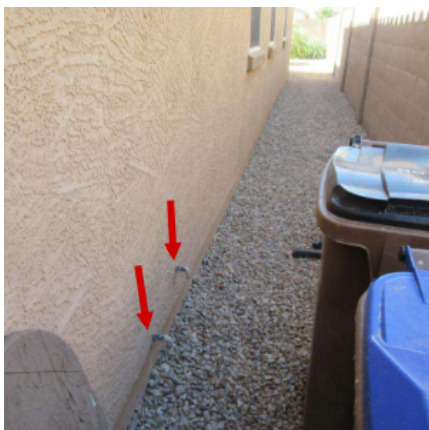
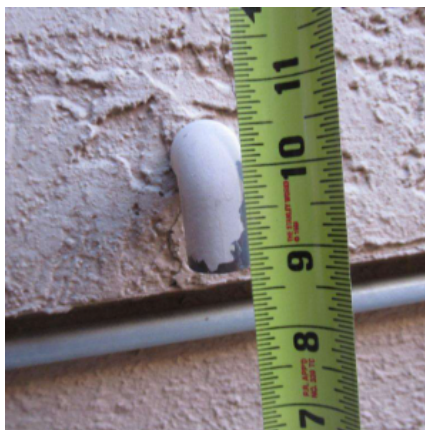
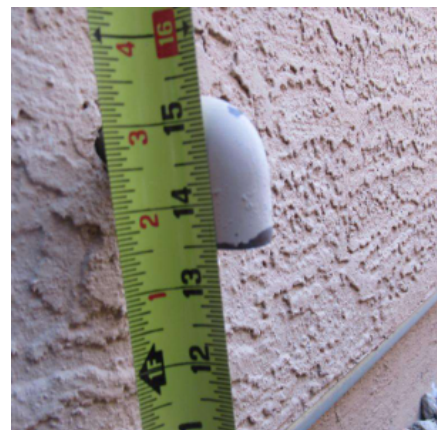
Image 5.1.1 Discharge Pipes on West Wall

5.1 Drain, Waste, Vent Piping Plumbing	Description	Condition	Location	Risk
	<ul style="list-style-type: none"> ABS Plastic PVC 	<ul style="list-style-type: none"> Improper Length 	<ul style="list-style-type: none"> Exterior West Wall 	<ul style="list-style-type: none"> Safety Concern

Repair or Replace - Immediately: Water heater discharge pipe is too short/far from ground. Steam dissipation can cause scalding to those standing nearby. Typically this should terminate 6 inches from the ground, but may vary by jurisdiction.

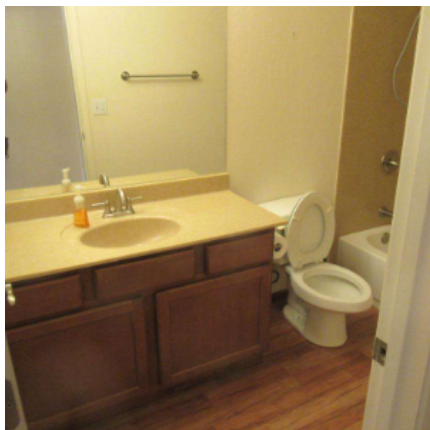
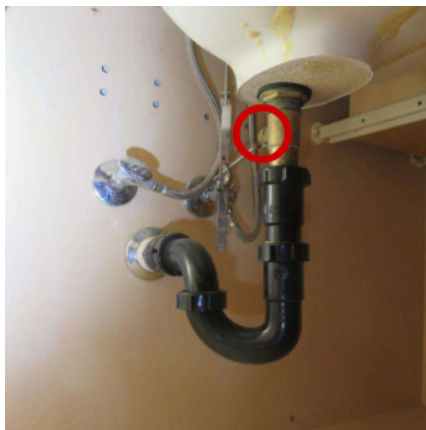
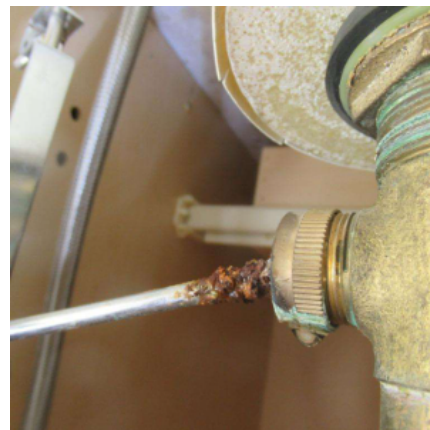
5.2 Bathroom Sinks

- Leaking

- Water Damage
- Sanitary Hazard

Repair or Replace - Immediately: A leak is present at the stopper rod/drain connection. The mechanism can be dismantled to check seals for wear or cracks.

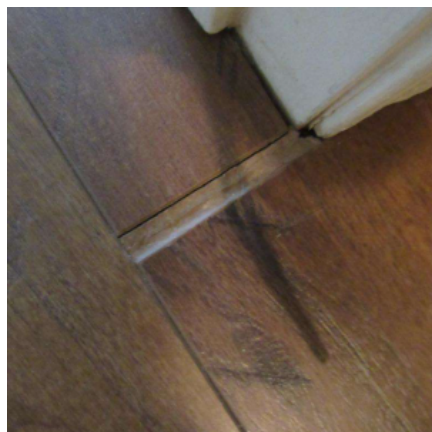
Image 6.1.1 Hardwood Flooring Gap - Master Bdrm Entry

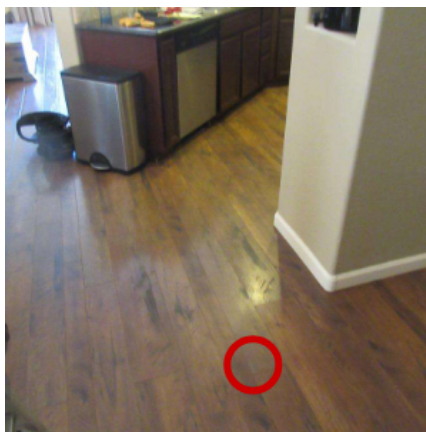
Monitor for Changes The corner of a hardwood flooring piece in the kitchen is delaminating and may get worse over time. Please monitor it at your discretion.

Image 6.1.2 Delamination spot in kitchen

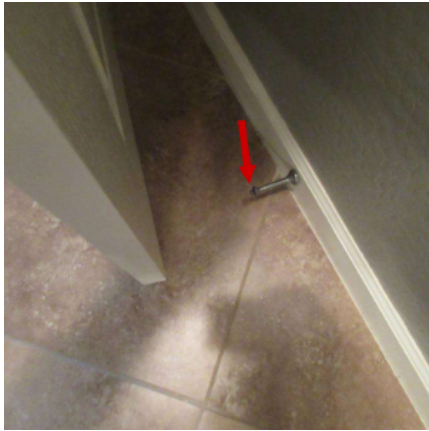
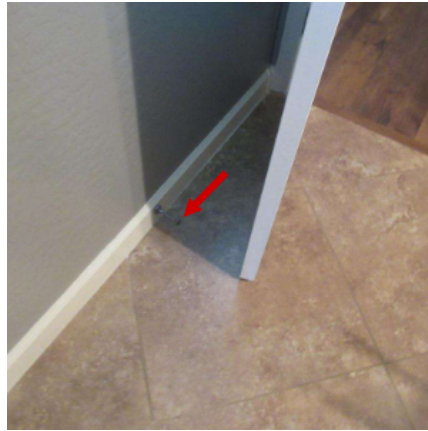
Repair or Replace Two of the door stops are missing the rubber bumpers that absorb the impact without denting the door. These can be purchased at your local hardware store and installed easily.

Image 6.2.1 Laundry Room

Image 6.2.2 Main Bathroom

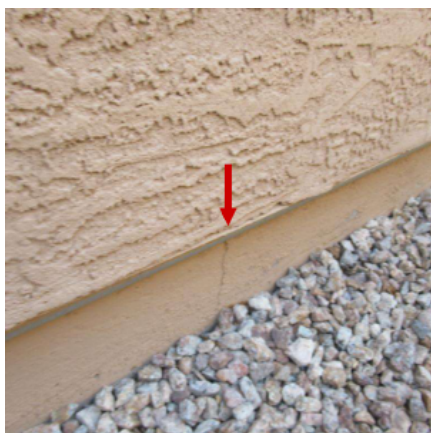
Image 7.1.1

7.1 Foundation Material Structure	Description	<ul style="list-style-type: none"> • Concrete 	Location	<ul style="list-style-type: none"> • East Side of Home
	Condition	<ul style="list-style-type: none"> • Hairline Cracked 	Risk	<ul style="list-style-type: none"> • Normal Settlement

There are typical settling cracks in the foundation walls that would not need a specialist evaluation.
