Property Inspection Report

Demo Report - 10013 River Drive Las Vegas, NV 89119

Date of Inspection
December 10th, 2020
11:30 AM

Inspected By
John Smith
InterNACHI #123456

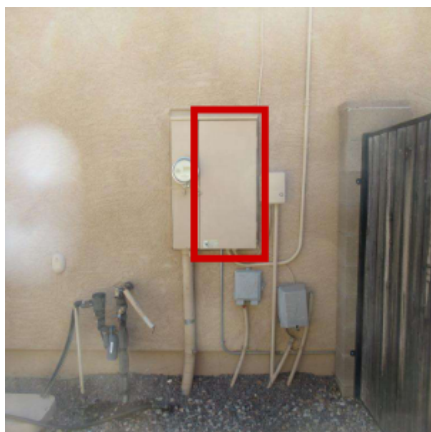
Image 3.2.1

Please take note of the location of the panel, as it will need to be accessed to reset breakers during home ownership.

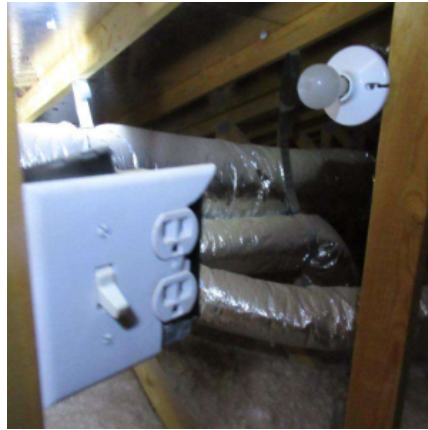
Image 3.4.2

| Condition | • Damaged | Risk | • Electrocutation Hazard |

Repair or Replace
